Inspection Fields Notes/ Inspection Report

Date: September 13, 2012

Subject: City of Bangor MS4 Inspection

MS4 Compliance Sampling Inspection
City of Bangor, Maine

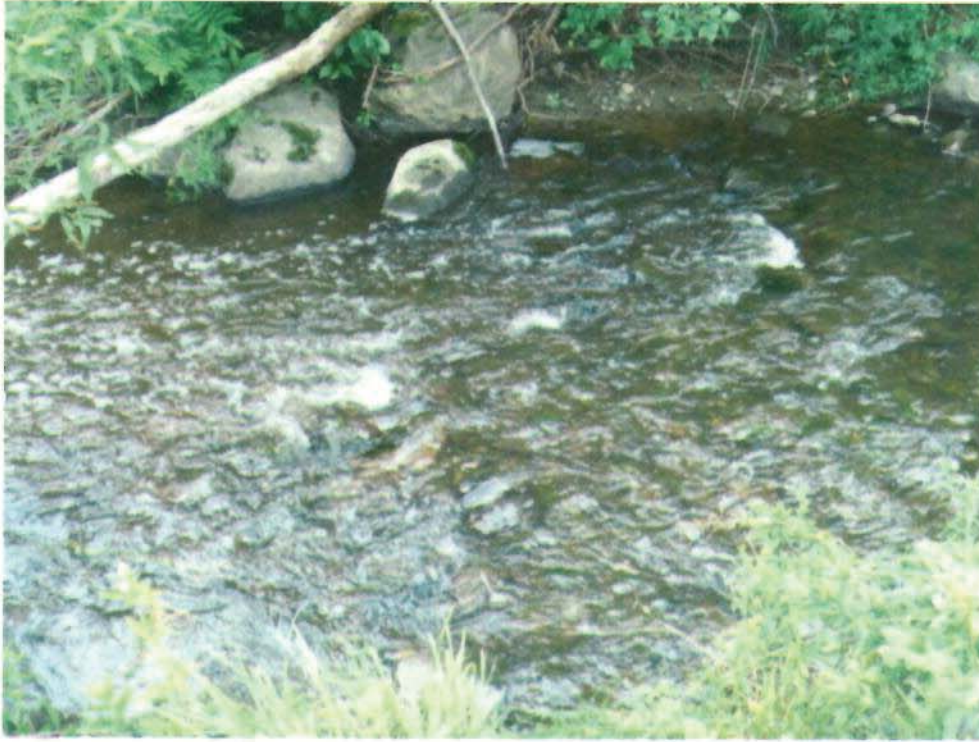
PJ-2-3: In stream sample located from the Penjajawoc Stream to the west of Bangor Federal Credit Union.

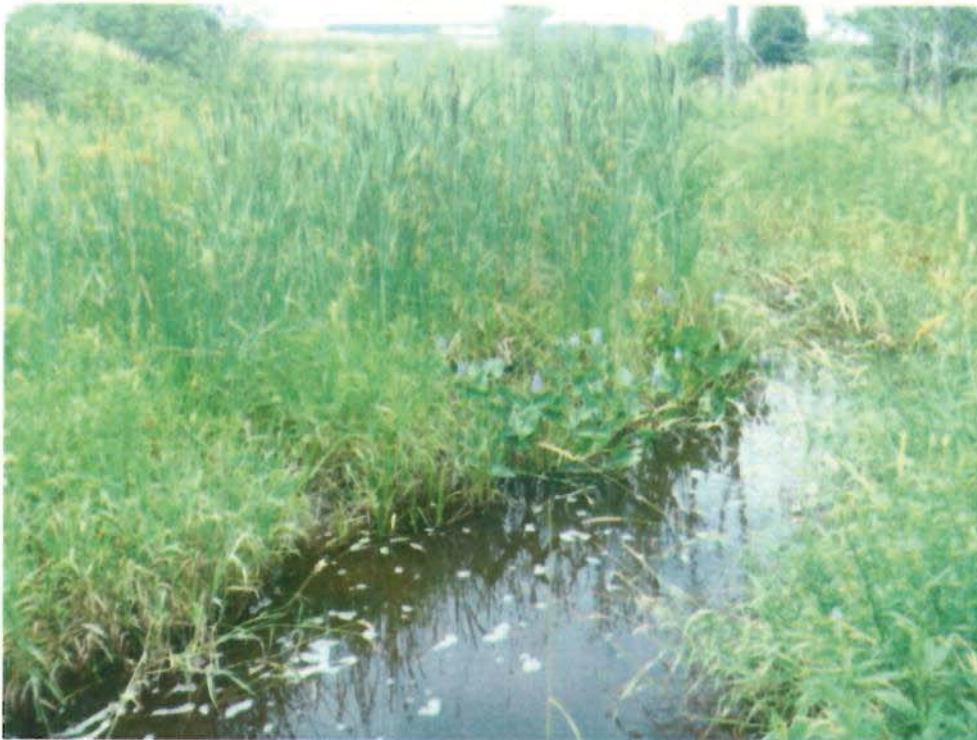
PJ-04: In stream sample located from the Penjajawoc Stream to the south of Wendy's Restaurant.

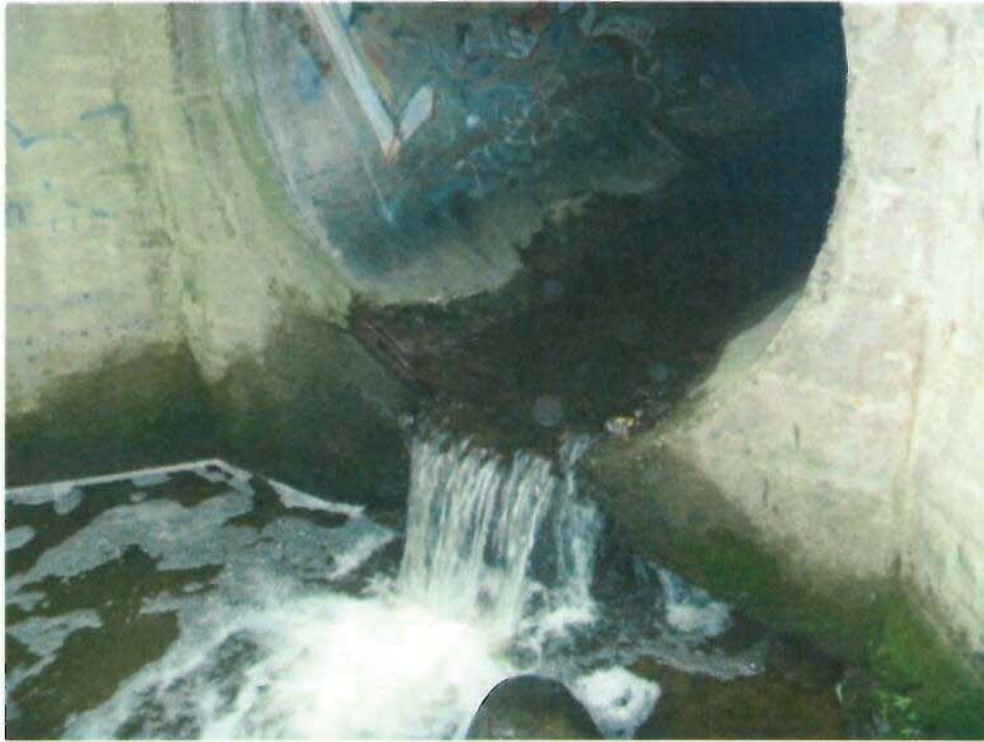
CB-01: In stream sample collected from Capehart Brook at the northeast end of Pushaw Road.

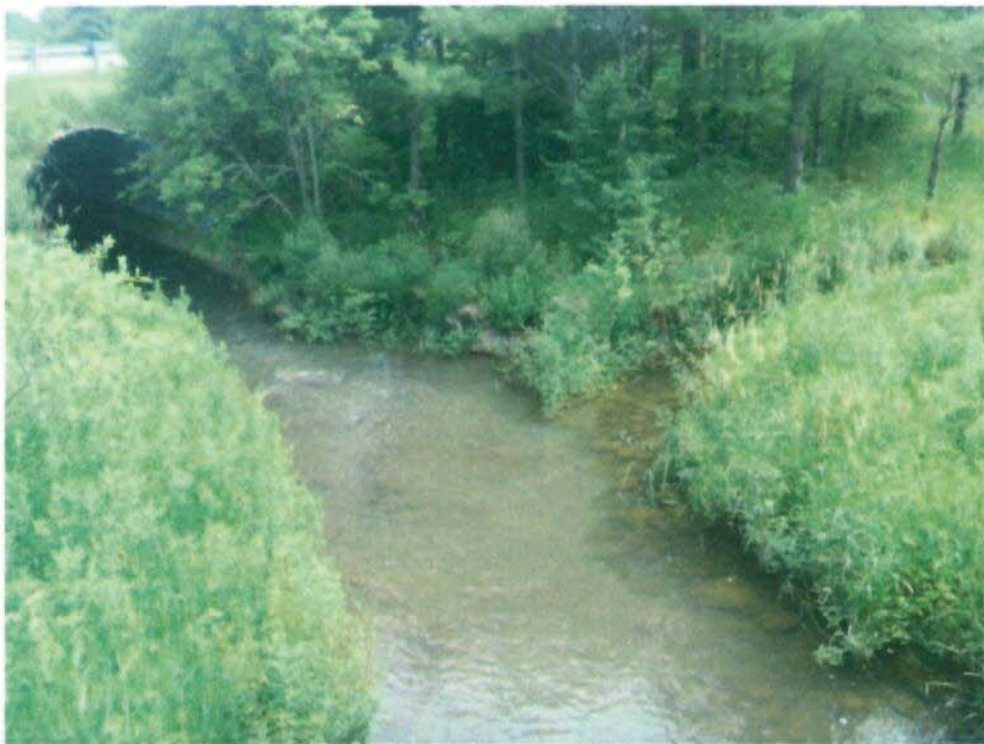
BR-04: In stream sample located along Birch Stream to the west of Godfrey Boulevard, downstream of DPW yard.

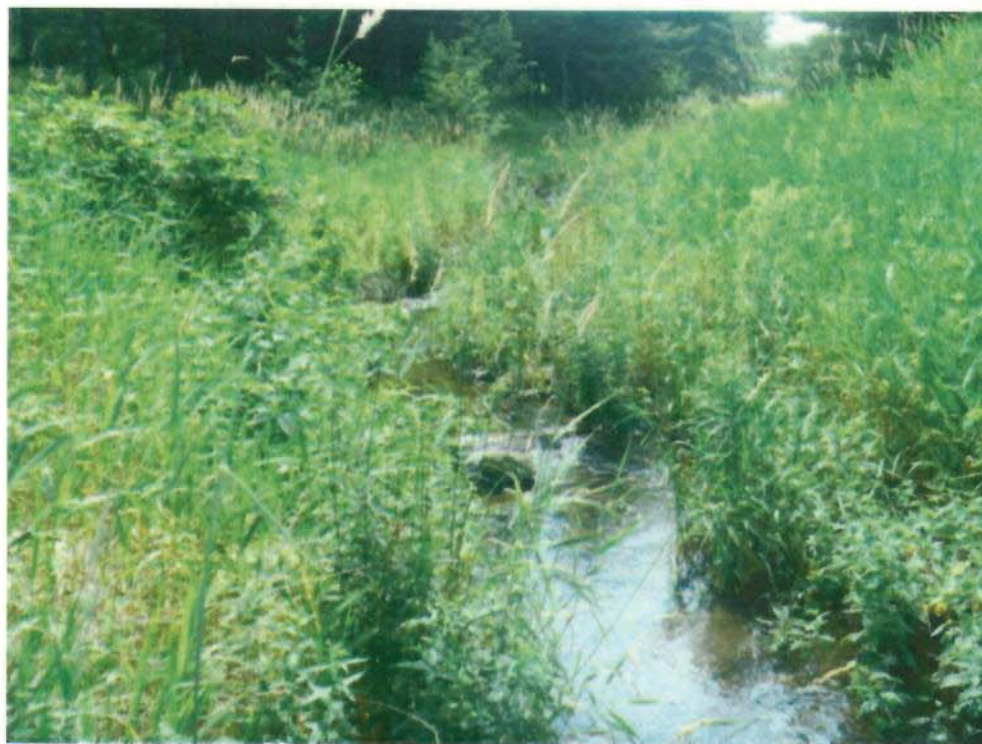
BRBBHYD: In stream sample located along Birch Stream to the east of Bia Commercial Industrial Park, prior to the confluence with BR-04.

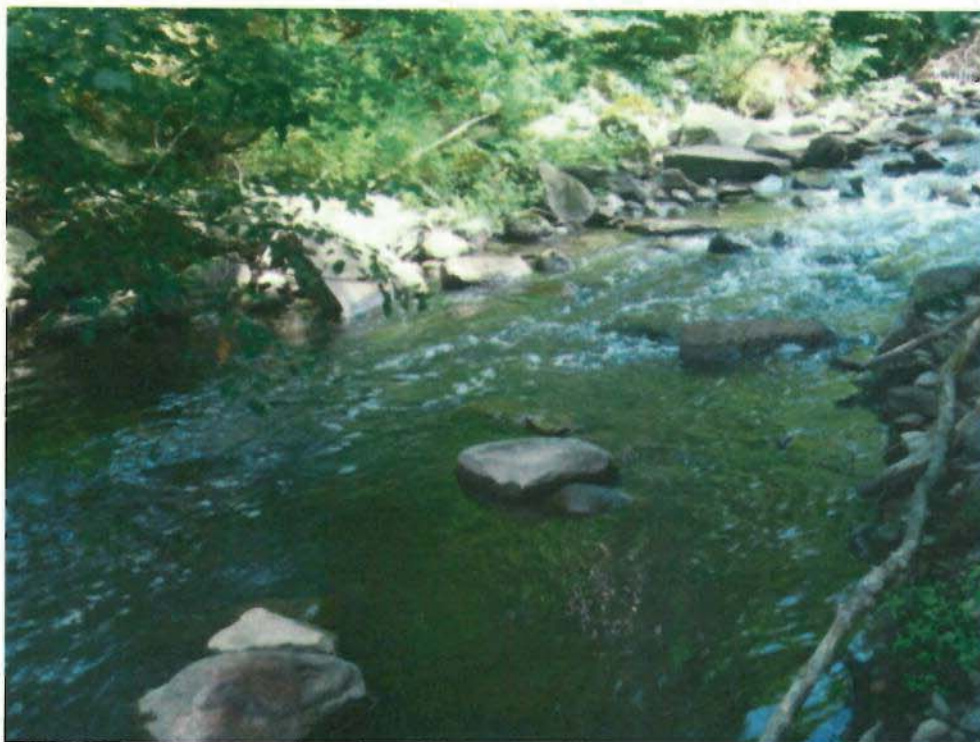
BR-01: In stream sample located along Birch Stream to the north of Ohio Street, prior to entering the Kenduskeag Stream.

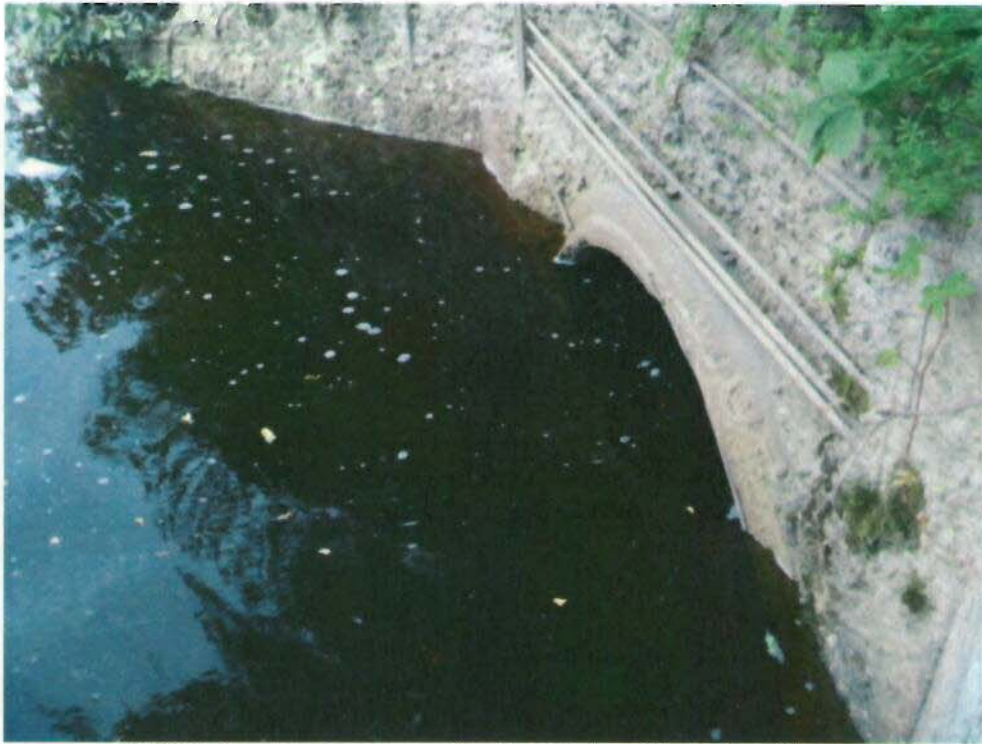
CSO11: Combined sewer overflow located along Kenduskeag Stream.

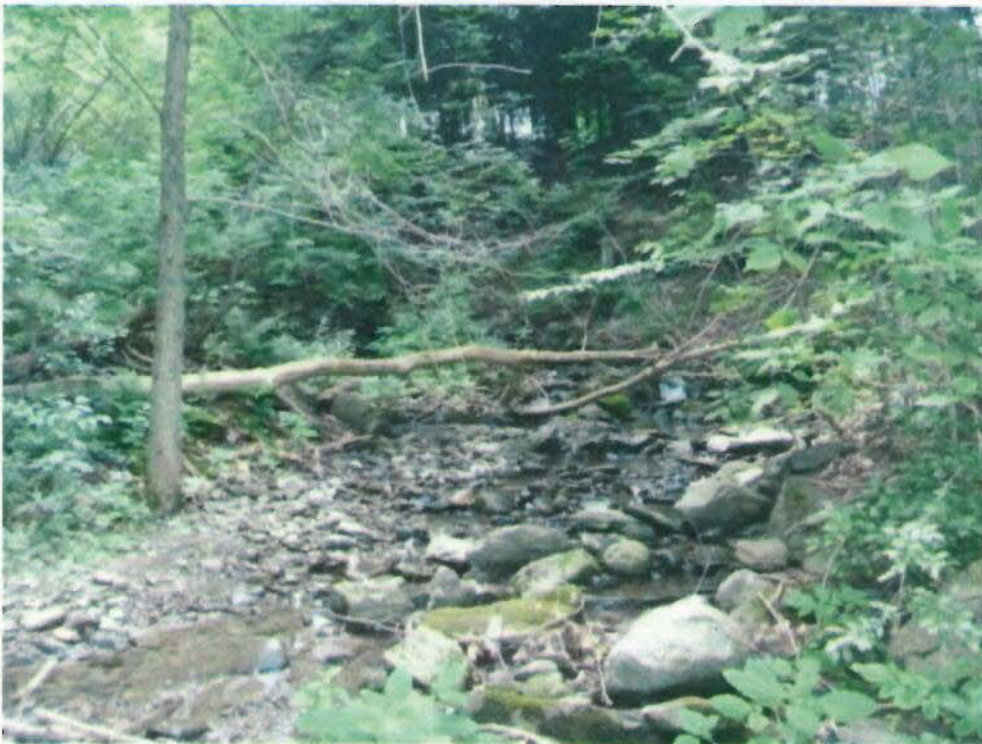
K-trib: In stream sample collected north of Mount Pleasant Cemetery.

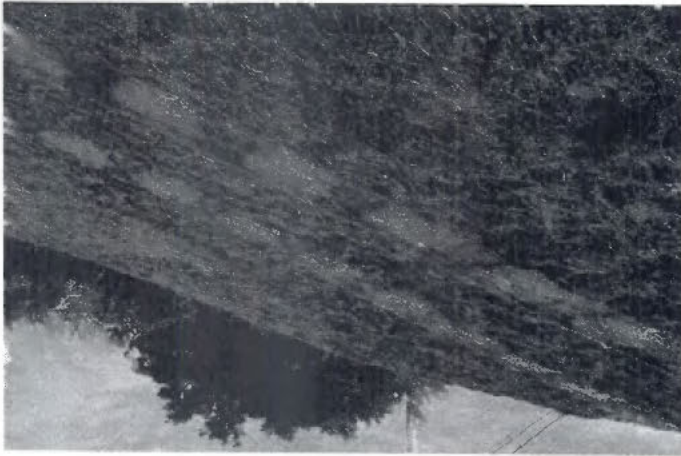
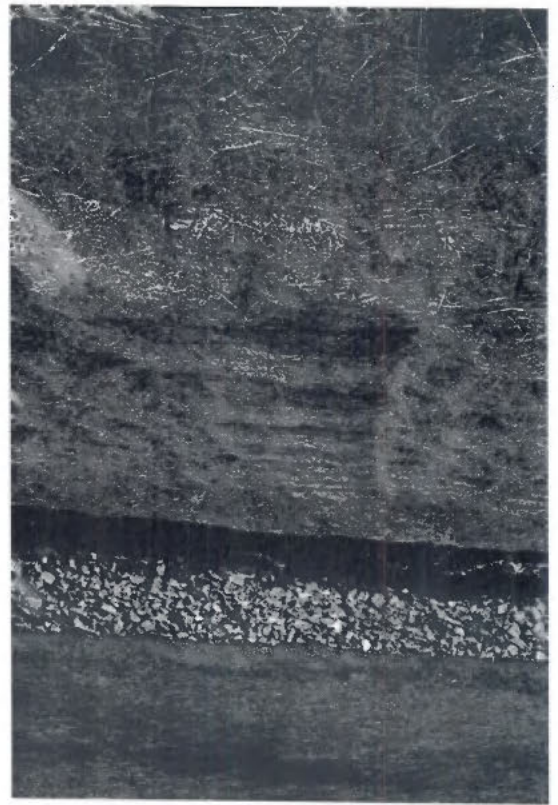
If yes, state corrective action & date completed. Washout was observed on Sylvan side slope, which is steep and loamed, seeded, and mulched shortly before rainfall and did not have much time to establish before rainfall. _____

Contractor restabilized slope with erosion control fabric in washout areas.

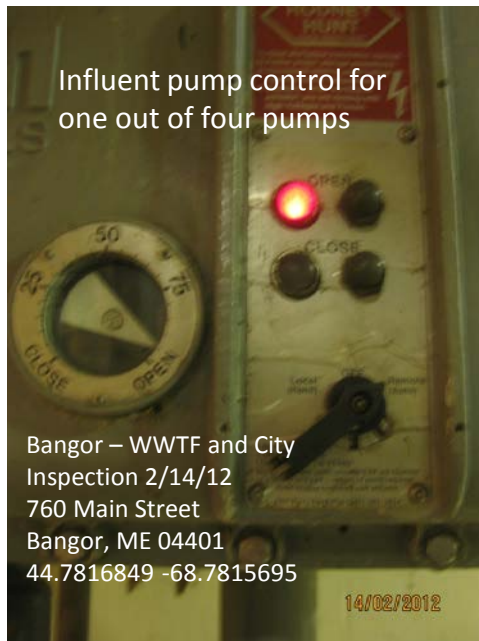
Influent pump control for
 one out of four pumps

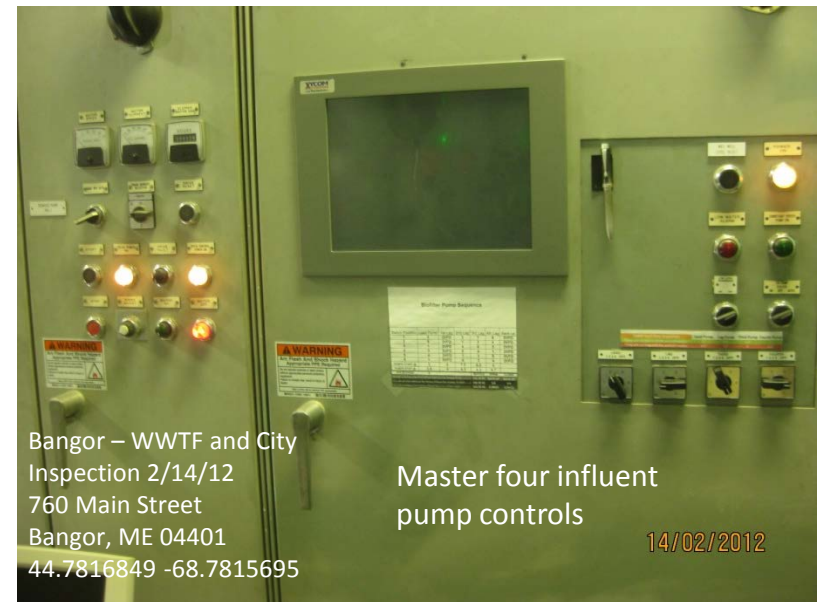
Master four influent
 pump controls

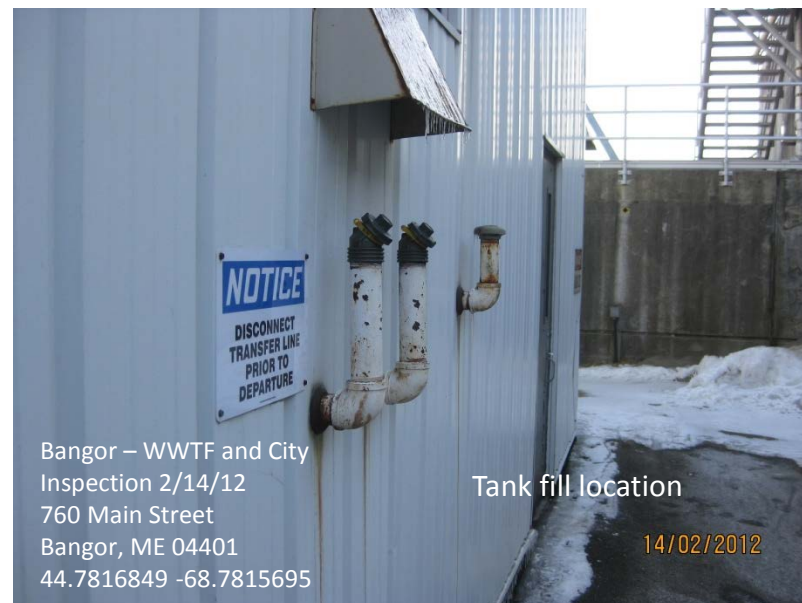
Tank fill location

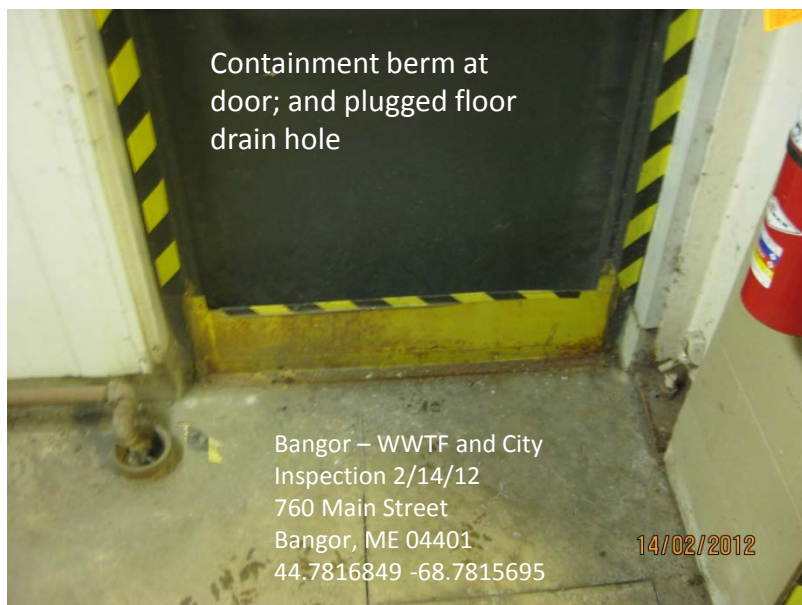
Containment berm at
 door; and plugged floor
 drain hole

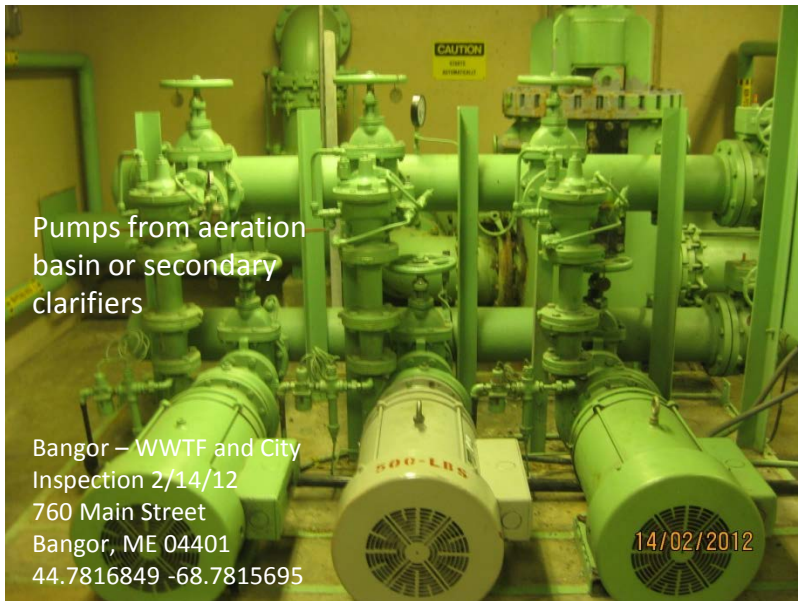
Pumps from aeration basin or secondary clarifiers

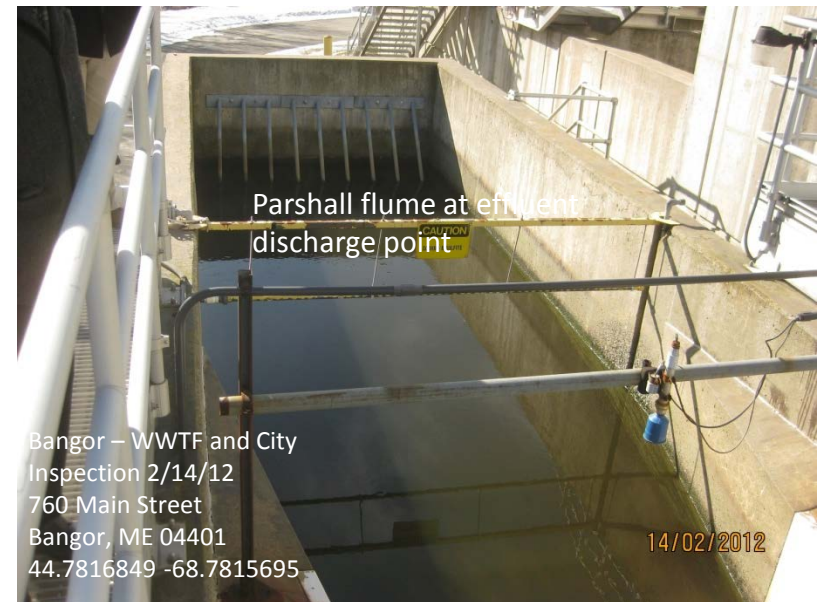
Parshall flume at effluent
discharge point
